HOW SAFE is YOUR LOCAL PLAYGROUND?

by Michael Kearnes

Standards Australia released AS/NZS 4422:1996 Playground Surfacing—Specifications, Requirement and Test Method in 1996. This standard was published more than 10 years ago. This article reviews how Local Government Authorities (LGAs) have adopted, implemented and enforced the requirements contained within this important Standard.

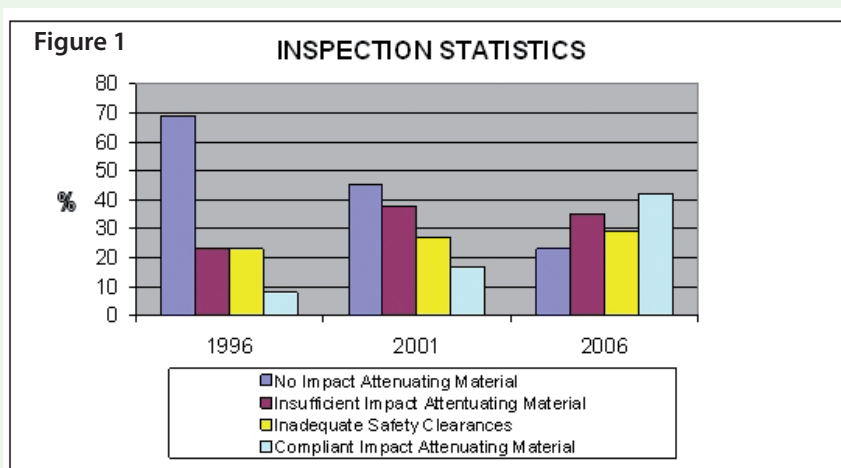
Figure 1: Almost 70% of all sites inspected in 1996 provided no safety surface material (impact attenuating surface) whilst less than 10% of sites provided full compliance to Australian Standard AS/NZS 4422:1996.

Of those sites that did have a loose fill material present, approximately 23% of all sites had an insufficient level of safety surface material and 23% all had inadequate safety clearances to the playground border of 2.5m.

In 2001, five years later, the sites that do not have any safety surface material have reduced to levels of approximately 45%, whilst sites that provided compliant levels have increased to almost 20%.

The levels of inadequate safety clearances have increased to almost 27% with insufficient amounts of loose fill material at almost 40%.

In 2006, 10 years after the introduction of AS/NZS 4422:1996 and now around 23% of all sites inspected still had no safety surface material present. The level of compliance was approximately at 42%.

The levels of inadequate safety clearances has increased slightly to 30% with insufficient levels of loose fill material at 35%.
